JOB REPORT: Company 2

EcoClear LLC (A GPM Company)

OVERVIEW

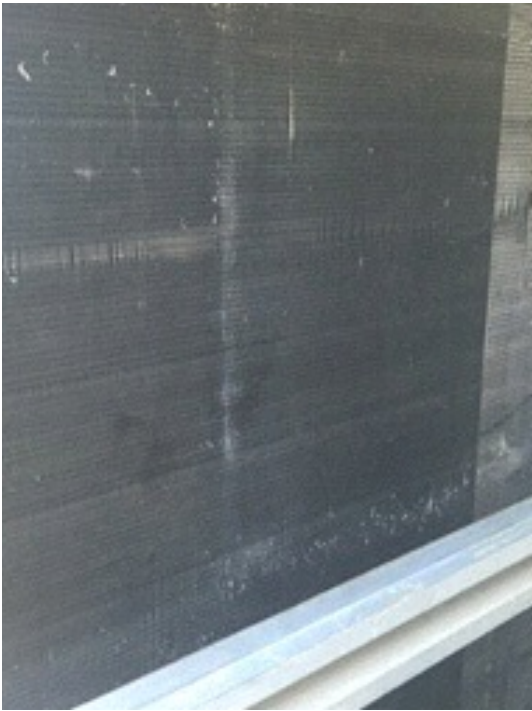
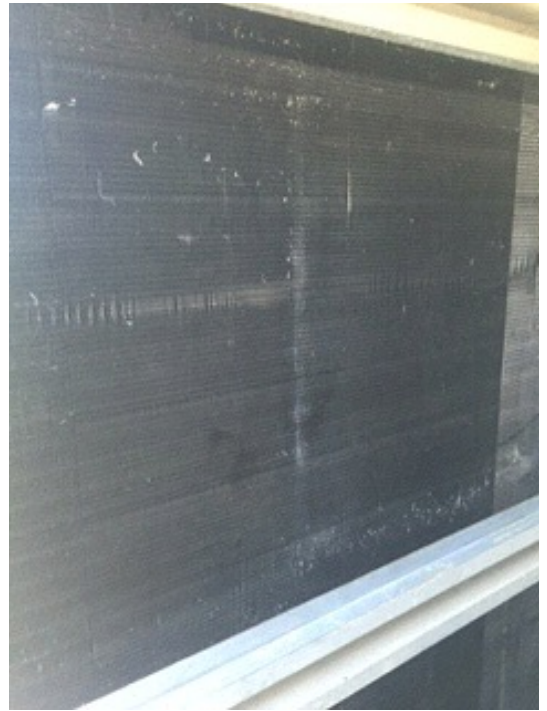
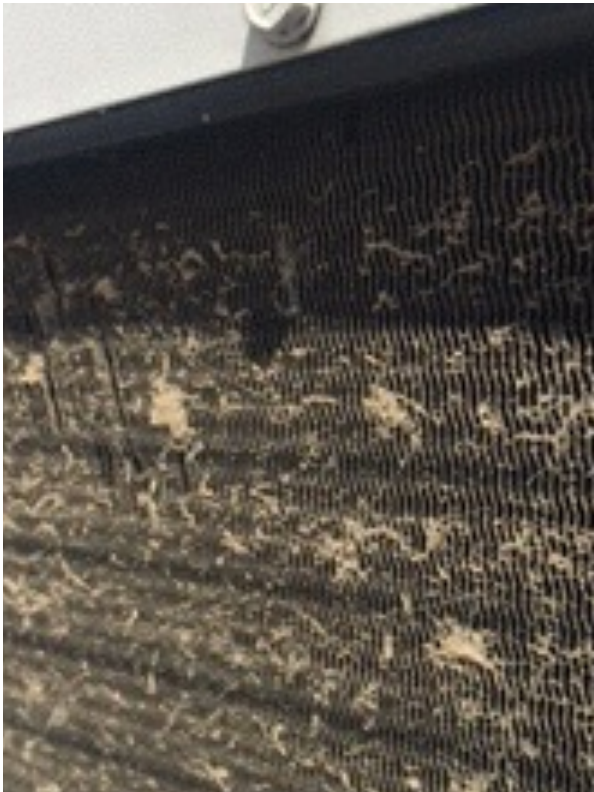
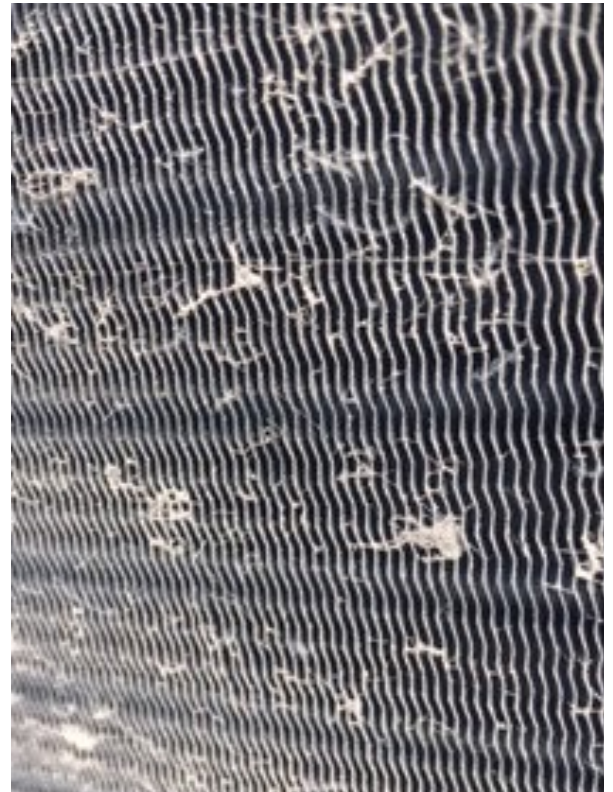
(Before)

EcoClear cleaned and coated 1 unit as a test at Company 2. Included in this report is data for this unit along with before and after pictures. The results from the coil cleaning showed that the unit had a fair amount of blockage and impaction within the coil. Due to the impaction it has limited the cooling capacity and increases the energy cost to operate this piece of equipment. The deep clean that was performed on this unit freed the impaction, allowed for greater heat transfer, increased capacity and energy savings, and increased CFM and Airflow. Below is the data that was received from the unit that was tested.

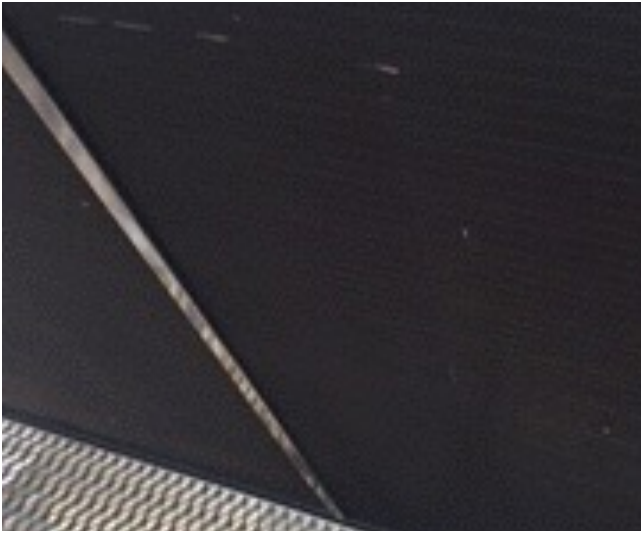
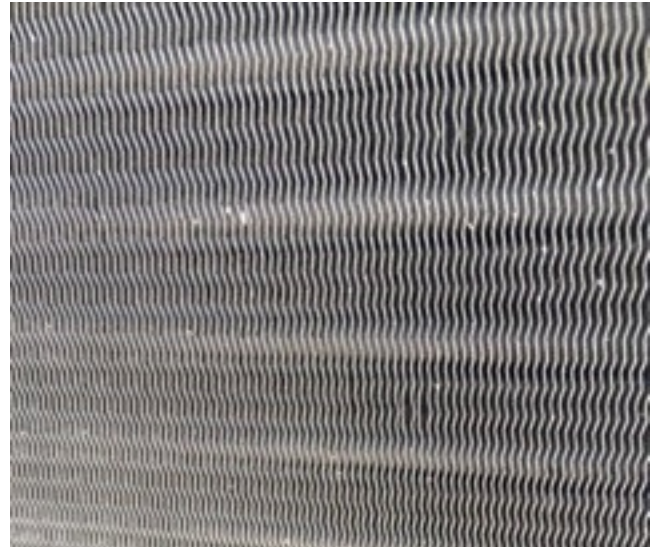
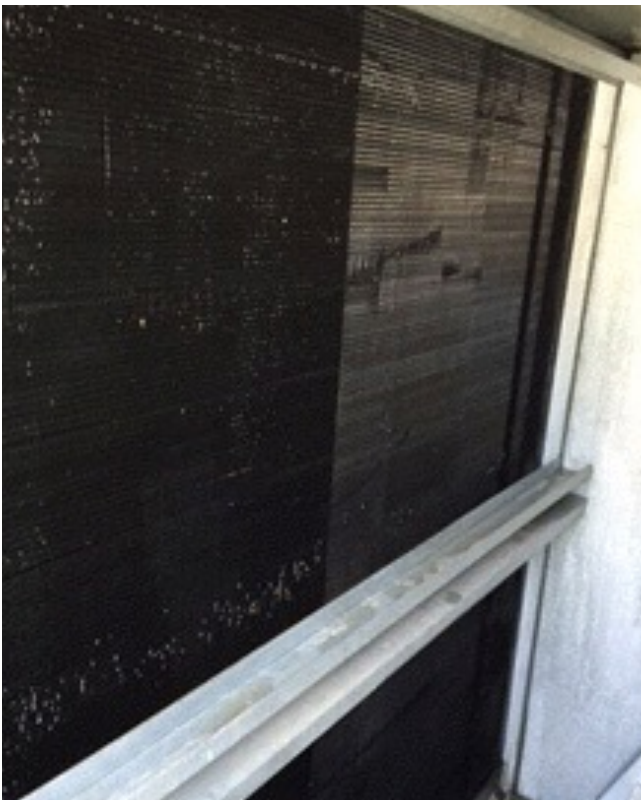
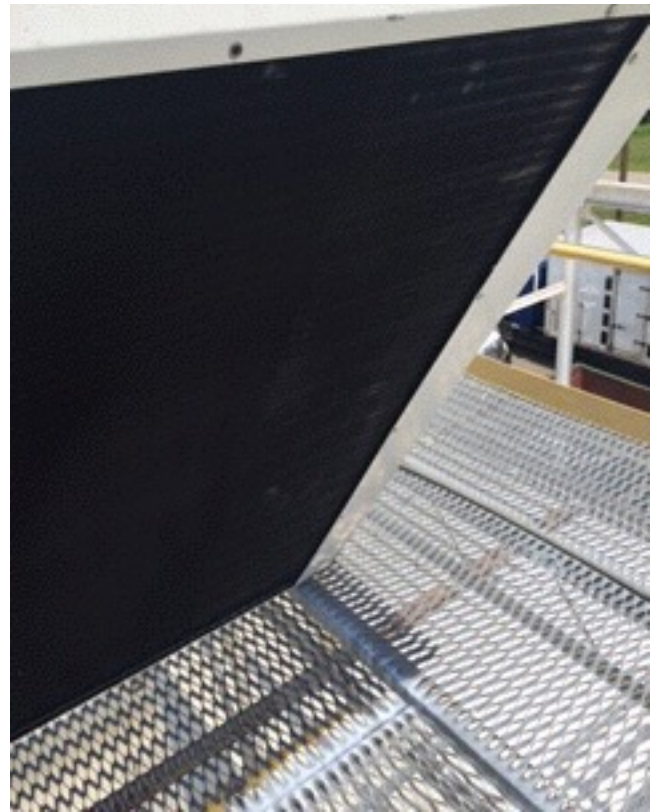
(After)

CFM INCREASE: 2,445 (36%)

CFM INCREASE: 1,289 (32%)
